LEVEL 2

# Your survey and valuation report

Thursday 22nd April 2021

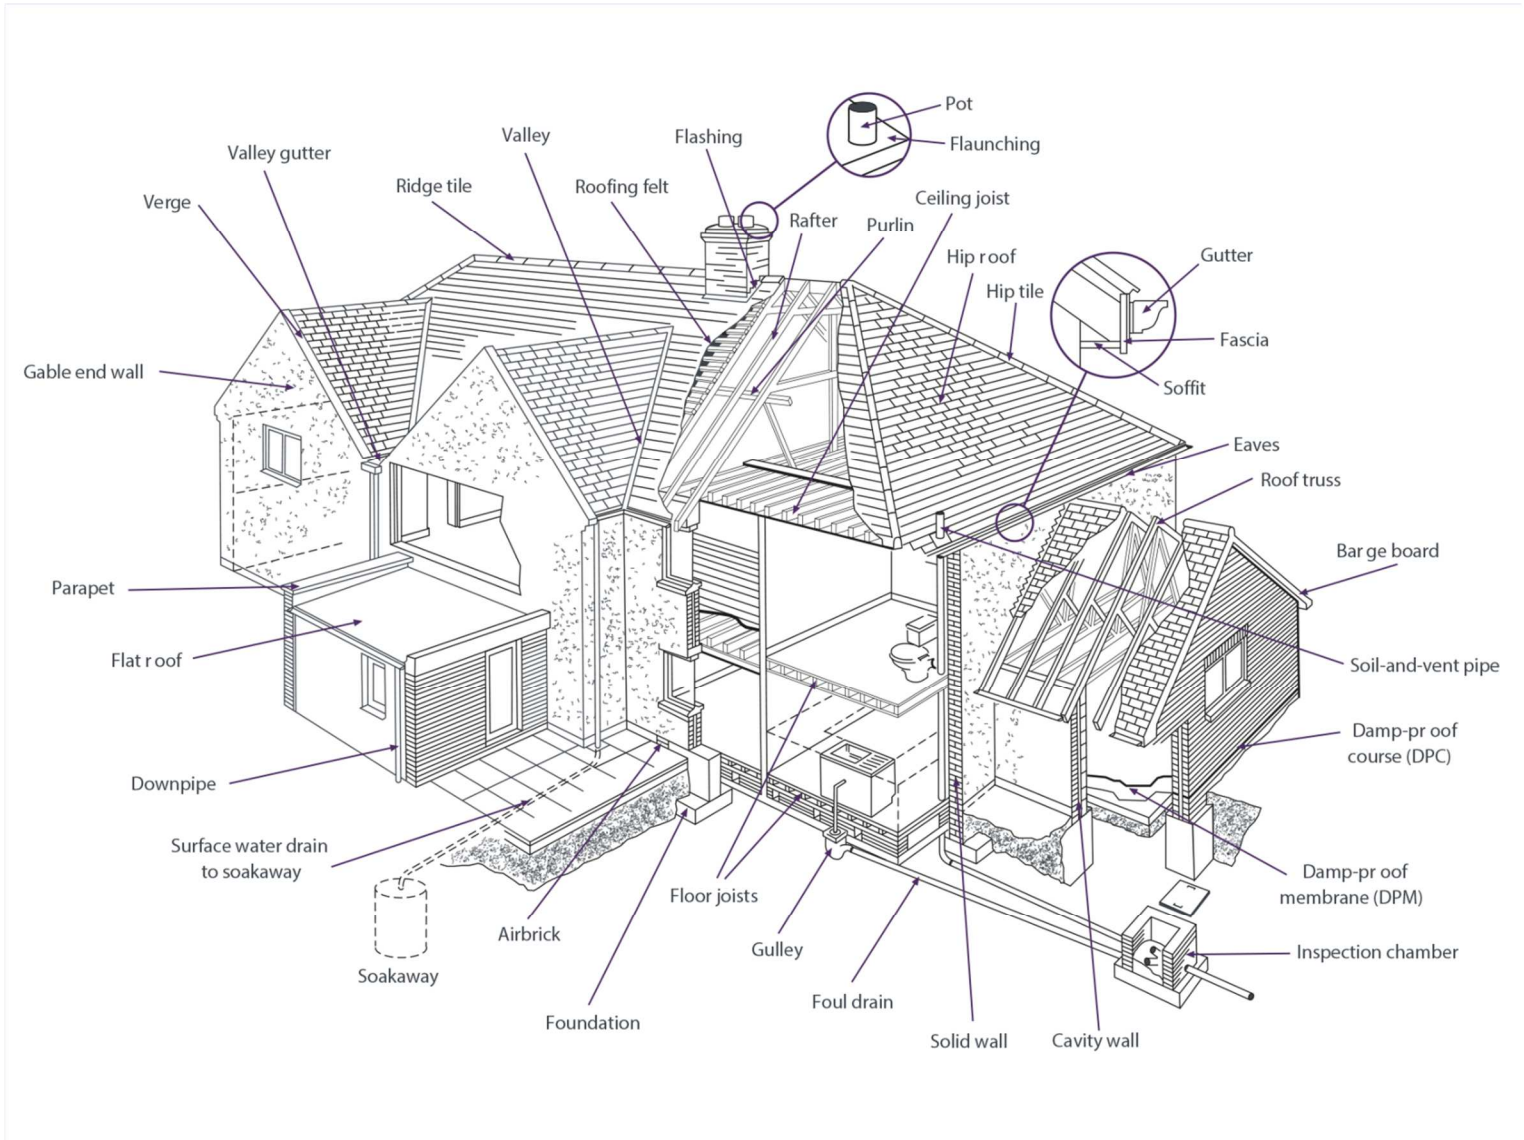
# Typical house diagram

This diagram illustrates where you may find some of the building elements referred to in the report.
